**Flood Control Project Maintenance
Levee Inspections**

Maintenance Issue Types Only, Levee Inspection Report By Mile - Spring 2018

Reclamation District No. 0524 Middle Roberts Island

Waterway	Bank	Unit Miles	Inspection Start/End	Inspector
Unit No. 01 San Joaquin River	Left	6.20	04/24/2018 04/24/2018	Richard Willoughby

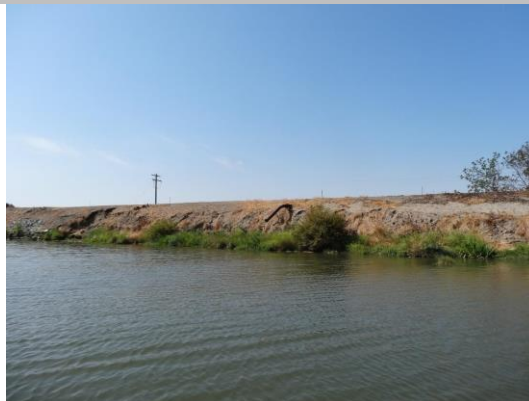
Photo 2 of 4 : SP_2018_RD0524_107_47_20180323_00106.jpg

LM Start	1.27	Rating **	A/W	Issue No.	47 (cont)
LM End	1.30	Issue Type +	Ma	Location *	WS
Category	Supplemental			GPS Latitude/Longitude	
				Start	End
Item	DWR Erosion Survey			37.931858 °	37.931887 °
				-121.328300 °	-121.328343 °
DWR ID	RD0524U01RM41.92				
Comment Code					
Inspector Comment					
5/17/2018. LM 1.30-1.31 was repaired by DWR the remainder of the site was un affected.					
09/13/2017. The erosion has developed along the levee slope. The length of the erosion is nearly doubled comparing to the prior survey.					
07/25/2016: No significant change observed.					
06/24/2015: No significant change observed.					
06/19/2014: No significant change observed.					
08/13/2013: New signs of animal activity were found.					
08/07/2012: The site was first reported in 2012 spring levee inspection report. [2017 Site ID:RD0524U01RM41.92]

Front view of the erosion.

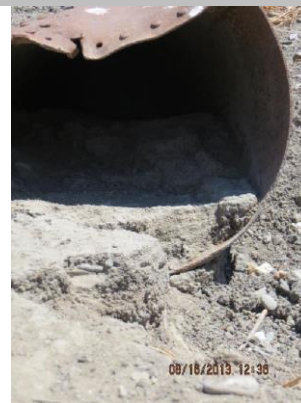
Photo 3 of 3 : UCIP_SP_2018_51319_29860.jpg

FS_ID:51319
DS_ID:20602
EP_NO: N/A
Repair Type: Urgent
Crossing Status: Found
UCIP Comments: 11/16/2016 same as previous inspection both ends are open. This pipe does not appear in use. Need to contact owner to determine status of crossing. If the crossing is abandoned or in use, owner will need to coordinate with the CVFPB to comply with Title 23 requirements. (O. Magana - DWR UCIP)08/16/2013 Pipe appears to be open on both ends. Abandoned and should be done so properly. (W. Wylie - DWR UCIP)
FIELD_STRUCT_DESC: *ABANDONED* 12-inch steel drainage pipe through the levee, 3.5 feet below the crown. Pipe is opened on the waterside (WS) and landside (LS) ends. The pump house referenced in O&M manual is missing from the LS (2013). [Additional Reference(s): DWR Levee Log, 2004. USACE San Joaquin O&M Manual 7, April 1964, (HLM 1.31)].
FS Date: 11/16/2016

Pipe appears open on both ends. View from LS slope.

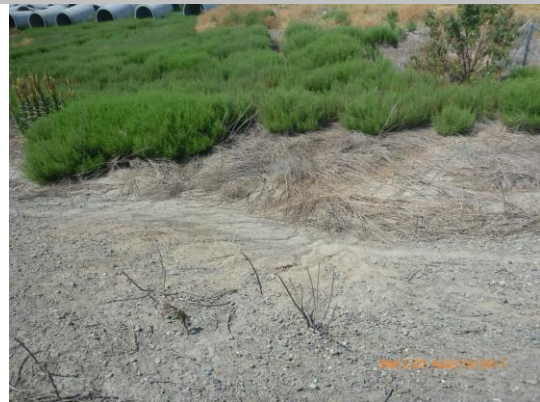
Photo 1 of 3 : LEVAL_SP_2018_532_4171.jpg

LM Start	1.33	Rating **	A/W	Issue No.	225
LM End	1.33	Issue Type +	Ma	Location *	
Category	Supplemental			GPS Latitude/Longitude	
				Start	End
Item	2017 Storm Damage			37.931500 °	37.931500 °
				-121.328200 °	-121.328200 °
DWR ID	DWR_RD0524_01_f_2017_225				
Comment Code					
Inspector Comment					
<p>Levee Evaluation Comments</p> <p>Description: Slope protection repairs are needed along the waterside slope due to erosion and riprap displacement from high water. Based upon levee inspections, it was determined the waterside levee slope is eroding, deteriorating, and degrading. The eroded levee sections need to be restored back to design standards to prevent further deterioration and damage.</p> <p>Site ID No: 532</p> <p>Site Designation: LMA-438</p> <p>Repair Type: Erosion</p> <p>Rating: Area of Concern</p> <p>Field Date: 8/10/2017</p> <p>Notes:</p>

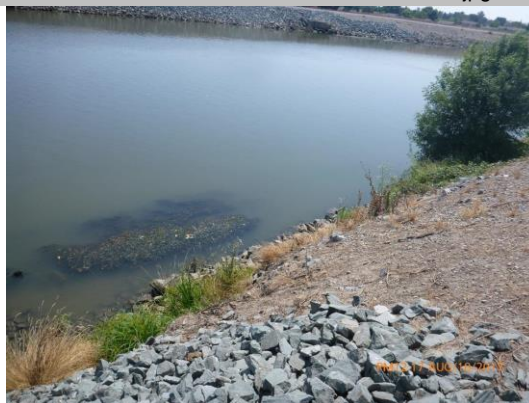
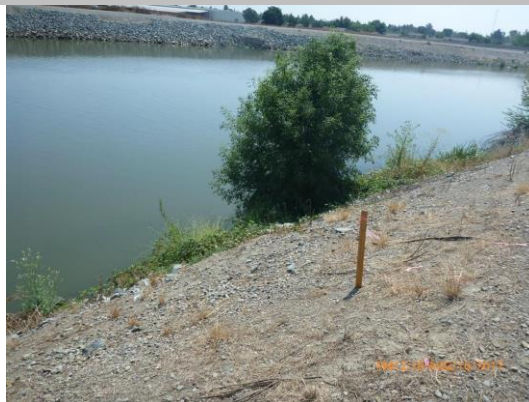
LM Start	1.33	Rating **	A/W	Issue No.	225 (cont)	
LM End	1.33	Issue Type +	Ma	Location *		
Category	Supplemental			GPS Latitude/Longitude		
				Start		End
Item	2017 Storm Damage			37.931500 °		37.931500 °
				-121.328200 °		-121.328200 °
DWR ID	DWR_RD0524_01_f_2017_225					
Comment Code						
Inspector Comment						
Levee Evaluation Comments						
Description:Slope protection repairs are needed along the waterside slope due to erosion and riprap displacement from high water. Based upon levee inspections, it was determined the waterside levee slope is eroding, deteriorating, and degrading. The eroded levee sections need to be restored back to design standards to prevent further deterioration and damage.						
Site ID No:532						
Site Designation:LMA-438						
Repair Type: Erosion						
Rating:Area of Concern						
Field Date:8/10/2017						
Notes:

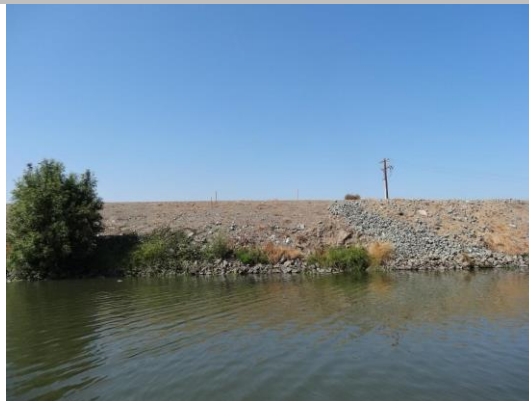
Photo 1 of 2 : SP_2018_RD0524_107_55_20180323_00117.jpg

LM Start	1.33	Rating **	M	Issue No.	55
LM End	1.33	Issue Type +	Ma	Location *	WS
Category	Supplemental			GPS Latitude/Longitude	
				Start	End
Item	DWR Erosion Survey			37.931510 °	37.931510 °
				-121.328120 °	-121.328120 °
DWR ID	RD0524U01RM41.95				
Comment Code					
Inspector Comment					
09/13/2017: The erosion is located immediately upstream of a protected levee section. [2017 Site ID:RD0524U01RM41.95]

Front view of the erosion.

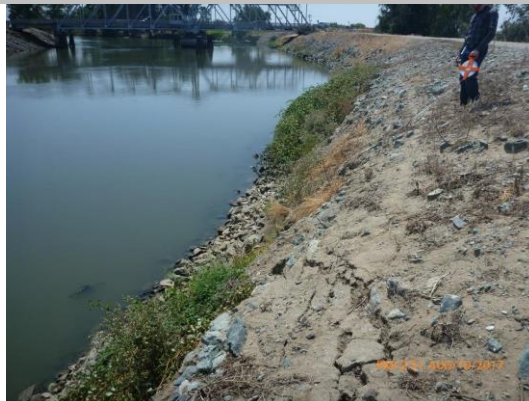
LM Start	1.43	Rating **	A/W	Issue No.	226 (cont)
LM End	1.44	Issue Type +	Ma	Location *	
Category	Supplemental			GPS Latitude/Longitude	
				Start	End
Item	2017 Storm Damage			37.930100 °	37.929900 °
				-121.328300 °	-121.328300 °
DWR ID	DWR_RD0524_01_f_2017_226				
Comment Code					
Inspector Comment					
Levee Evaluation Comments					
Description:Slope protection repairs are needed along the waterside slope due to erosion and riprap displacement from high water. Based upon levee inspections, it was determined the waterside levee slope is eroding, deteriorating, and degrading. The eroded levee sections need to be restored back to design standards to prevent further deterioration and damage.					
Site ID No:530					
Site Designation:LMA-436					
Repair Type: Erosion					
Rating:Area of Concern					
Field Date:8/10/2017					
Notes:

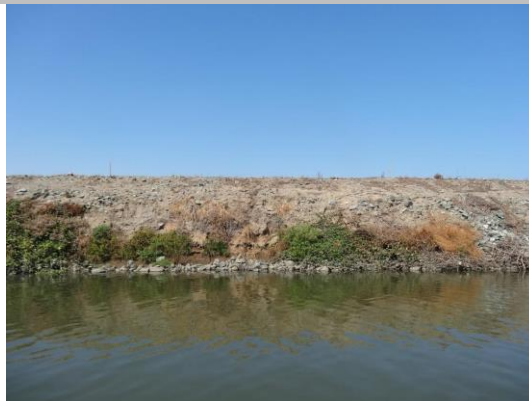
Photo 3 of 4 : SP_2018_RD0524_107_60_20180323_00128.jpg

LM Start	1.45	Rating **	U	Issue No.	60 (cont)
LM End	1.47	Issue Type +	Ma	Location *	WS
Category	Supplemental			GPS Latitude/Longitude	
				Start	End
Item	DWR Erosion Survey			37.929650 °	37.929650 °
				-121.328110 °	-121.328110 °
DWR ID	RD0524U01RM42.09				
Comment Code					
Inspector Comment					
09/13/2017: No significant change observed.					
07/25/2016: No significant change observed.					
06/24/2015: No significant change observed.					
06/19/2014: No significant change observed.					
08/13/2013: The site is located approximately 400 ft. downstream SR 4 Bridge. Dense vegetation is visible at the toe. [2017 Site ID:RD0524U01RM42.09]

Close view of the erosion. Note the vegetation at the site.

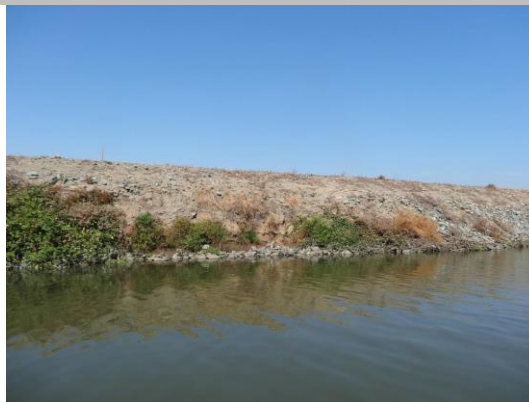
Photo 4 of 4 : SP_2018_RD0524_107_60_20180323_00129.jpg

Close view of the erosion.

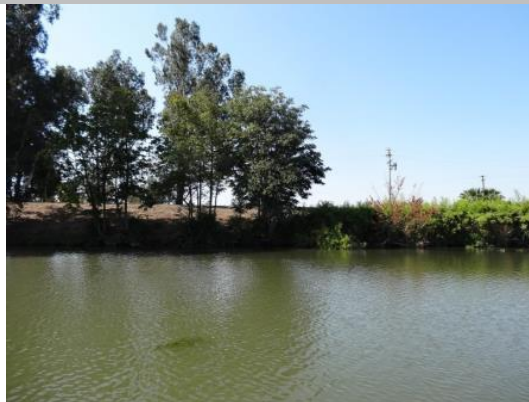
Photo 1 of 3 : SP_2018_RD0524_107_62_20180323_00131.jpg

09/13/2017: No significant change observed.
 07/25/2016: No significant change observed.
 06/24/2015: No significant change observed.
 06/19/2014: No significant change observed.
 08/13/2013: No significant change observed.
 08/07/2012: The site has been visited by boat survey. No significant change observed
 08/23/2011: No significant change observed on site. Trees concerned still in place.
 09/07/2010: No significant change observed on site. The concern here is the undermining of the levee toe where most of trees are. There are erosion pockets lined along the lower slope and at the base of the trees, exposing tree roots. There is minimal slope protection.
 09/29/2009: The lower slope is lined with minor erosion pockets; some tree roots are exposed; there is visible undermining of the levee toe; site is immediately upstream of the Highway 4 Bridge; the bridge is possibly causing a scour to occur, eroding the bank. [2017 Site ID:RD0524U01RM42.2]

Front view of the site where undermining has occurred.

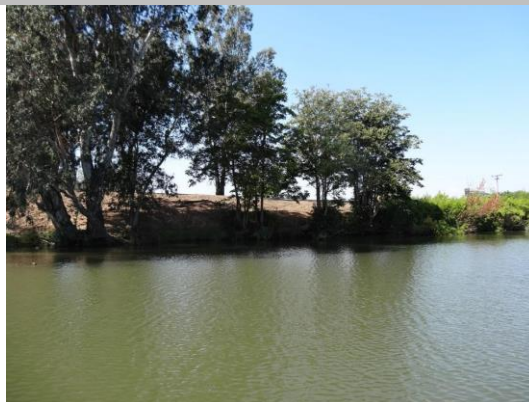
Photo 2 of 3 : SP_2018_RD0524_107_62_20180323_00132.jpg

Close view of the erosion.

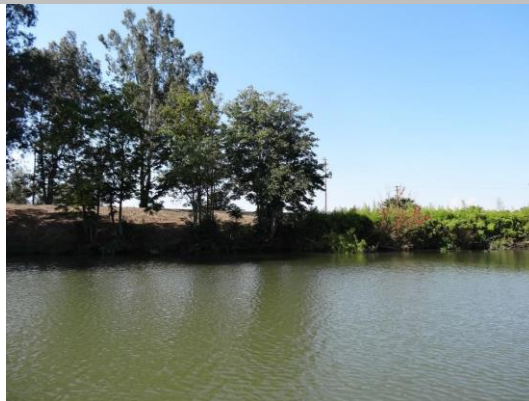
Photo 3 of 3 : SP_2018_RD0524_107_62_20180323_00133.jpg

Comment Code						
Inspector Comment						
09/13/2017: No significant change observed. 07/25/2016: No significant change observed. 06/24/2015: No significant change observed. 06/19/2014: No significant change observed. 08/13/2013: No significant change observed. 08/07/2012: The site has been visited by boat survey. No significant change observed 08/23/2011: No significant change observed on site. Trees concerned still in place. 09/07/2010: No significant change observed on site. The concern here is the undermining of the levee toe where most of trees are. There are erosion pockets lined along the lower slope and at the base of the trees, exposing tree roots. There is minimal slope protection. 09/29/2009: The lower slope is lined with minor erosion pockets; some tree roots are exposed; there is visible undermining of the levee toe; site is immediately upstream of the Highway 4 Bridge; the bridge is possibly causing a scour to occur, eroding the bank. [2017 Site ID:RD0524U01RM42.2]

Front view of the erosion. Dense vegetation is visible.

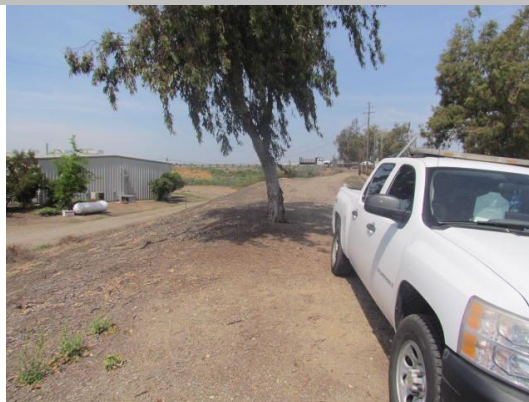
Photo 1 of 1 : SP_2018_RD0524_107_173_20180323_00236.jpg

LM Start	1.58	Rating **	U	Issue No.	173
LM End	1.58	Issue Type +	Ma	Location *	LS
Category	Earthen Levee			GPS Latitude/Longitude	
				Start	End
Item	Trim / Thin Trees			37.927975 °	37.927975 °
				-121.328088 °	-121.328088 °
DWR ID	DWR_RD0524_01_s_2015_173				
Comment Code					
T1 : Trim trees to at least five feet above ground level.					
Inspector Comment					
Tree is located on landside shoulder and crown should be removed.

Looking northwest at tree on within levee crown.

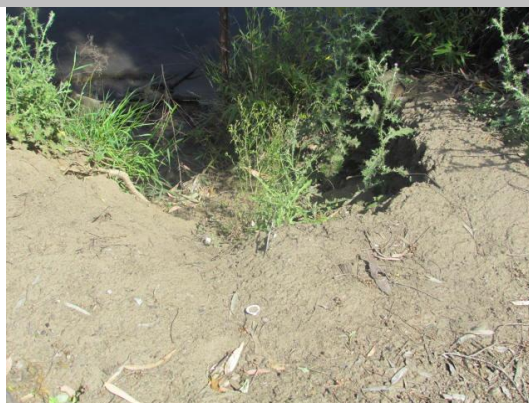
Photo 2 of 3 : SP_2018_RD0524_107_26_20180323_00058.jpg

Looking east at waterward erosion.

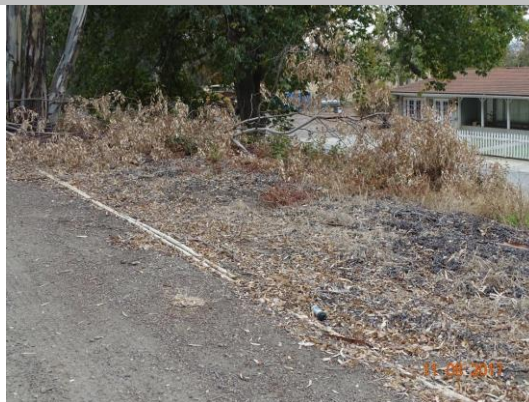
Photo 1 of 1 : SP_2018_RD0524_107_240_20180323_00351.jpg

LM Start	1.66	Rating **	M	Issue No.	240
LM End	1.66	Issue Type +	Ma	Location *	LS
Category	Earthen Levee			GPS Latitude/Longitude	
				Start	End
Item	Encroachments			37.927159 °	37.927159 °
				-121.327022 °	-121.327022 °
DWR ID	DWR_RD0524_01_f_2017_240				
Comment Code					
TR : Tree or limb					
Inspector Comment

Looking southeast at the landside slope.

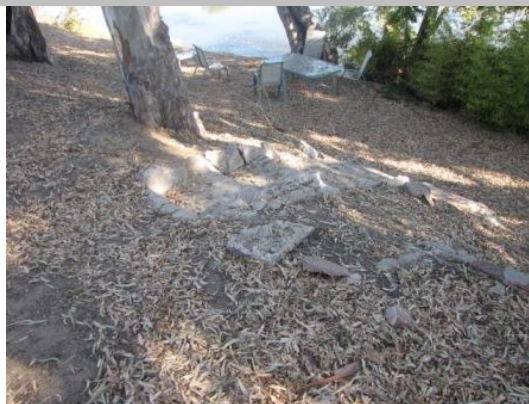
Photo 1 of 3 : SP_2018_RD0524_107_45_20180323_00098.jpg

LM Start	1.67	Rating **	U	Issue No.	45
LM End	1.67	Issue Type +	Ma	Location *	WS
Category	Earthen Levee			GPS Latitude/Longitude	
				Start	End
Item	Encroachments			37.927018 °	37.927018 °
				-121.326872 °	-121.326872 °
DWR ID	DWR_RD0524_01_s_2012_45				
Comment Code					
ST : Stairway					
Inspector Comment					
Stairs and retaining wall.

Looking northeast at non-permitted concrete stairs on waterside slope.

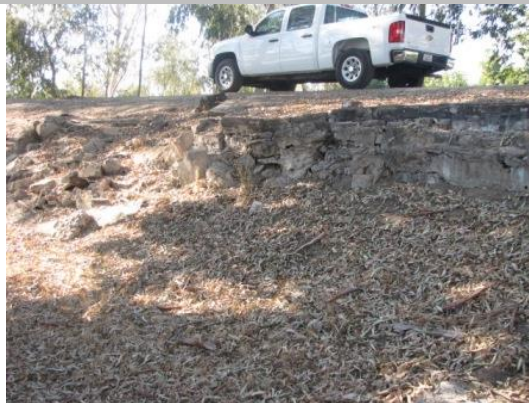
Photo 2 of 3 : SP_2018_RD0524_107_45_20180323_00099.jpg

LM Start	1.67	Rating **	U	Issue No.	45 (cont)	
LM End	1.67	Issue Type +	Ma	Location *	WS	
Category	Earthen Levee			GPS Latitude/Longitude		
				Start		End
Item	Encroachments			37.927018 °		37.927018 °
				-121.326872 °		-121.326872 °
DWR ID	DWR_RD0524_01_s_2012_45					
Comment Code						
ST : Stairway						
Inspector Comment						
Stairs and retaining wall.

Looking southwest at retaining wall connected to concrete stairs.

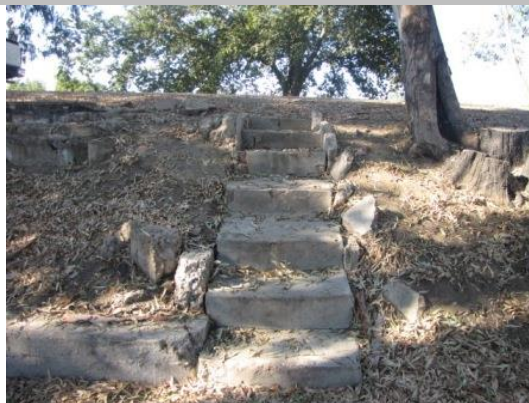
Photo 3 of 3 : SP_2018_RD0524_107_45_20180323_00100.jpg

Looking west at concrete stairs on waterside slope.

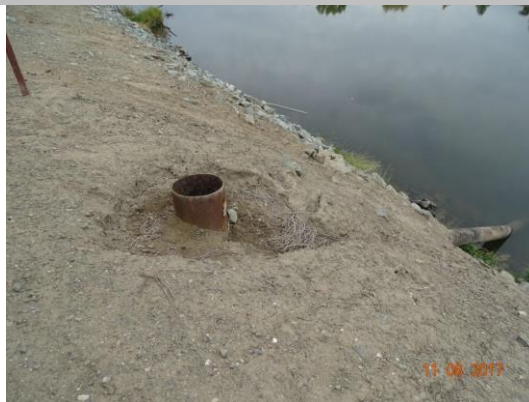
Photo 1 of 4 : SP_2018_RD0524_107_31_20180323_00069.jpg

LM Start	2.25	Rating **	U	Issue No.	31
LM End	2.25	Issue Type +	Ma	Location *	WS
Category	Earthen Levee			GPS Latitude/Longitude	
				Start	End
Item	Slope Stability			37.920493 °	37.920493 °
				-121.320565 °	-121.320565 °
DWR ID	DWR_RD0524_01_s_2012_31				
Comment Code					
S1 : Repair slope instability.					
Inspector Comment					
Slope instability probably cause by leak in irrigation pipe. Pipe should be inspected internally.

Looking northwest at waterside slope.

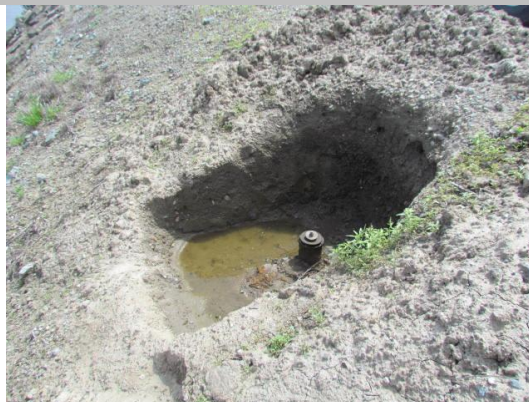
Photo 2 of 4 : SP_2018_RD0524_107_31_20180323_00070.jpg

Looking south at siphon on waterward slope.

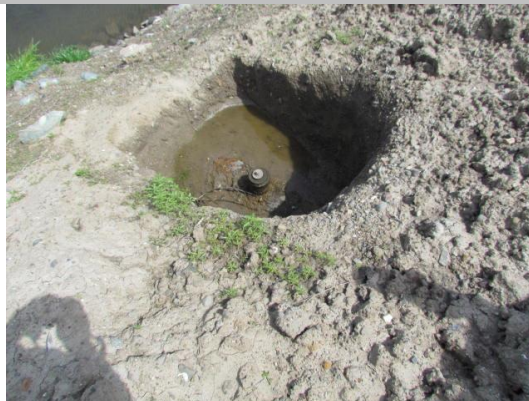
Photo 3 of 4 : SP_2018_RD0524_107_31_20180323_00071.jpg

LM Start	2.25	Rating **	U	Issue No.	31 (cont)	
LM End	2.25	Issue Type +	Ma	Location *	WS	
Category	Earthen Levee			GPS Latitude/Longitude		
				Start		End
Item	Slope Stability			37.920493 °		37.920493 °
				-121.320565 °		-121.320565 °
DWR ID	DWR_RD0524_01_s_2012_31					
Comment Code						
S1 : Repair slope instability.						
Inspector Comment						
Slope instability probably cause by leak in irrigation pipe. Pipe should be inspected internally.

Looking east at siphon on waterward slope.

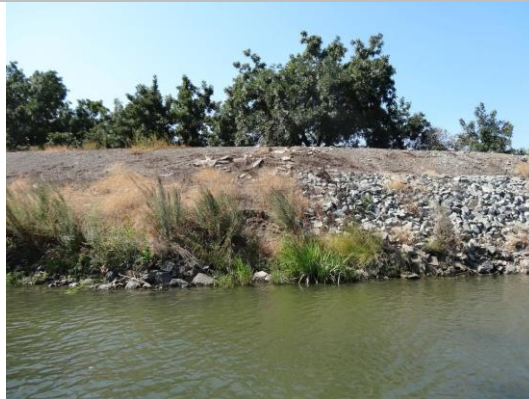
Photo 1 of 3 : SP_2018_RD0524_107_70_20180323_00140.jpg

LM Start	2.30	Rating **	M	Issue No.	70
LM End	2.30	Issue Type +	Ma	Location *	WS
Category	Supplemental			GPS Latitude/Longitude	
				Start	End
Item	DWR Erosion Survey			37.920150 °	37.920150 °
				-121.319700 °	-121.319700 °
DWR ID	RD0524U01RM42.9				
Comment Code					
Inspector Comment					
09/13/2017: The erosion is located immediately upstream of a repaired levee section. [2017 Site ID:RD0524U01RM42.9]

Front view of the pocket erosion.

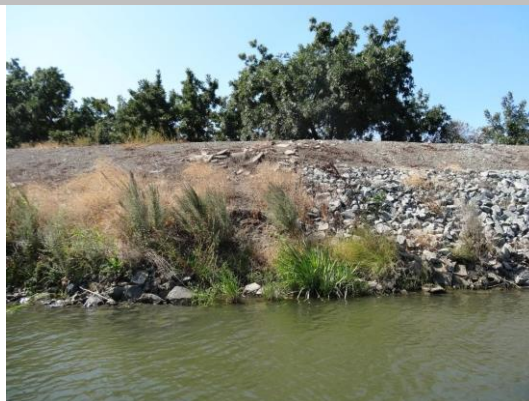
Photo 2 of 3 : SP_2018_RD0524_107_70_20180323_00141.jpg

Close view of the erosion.

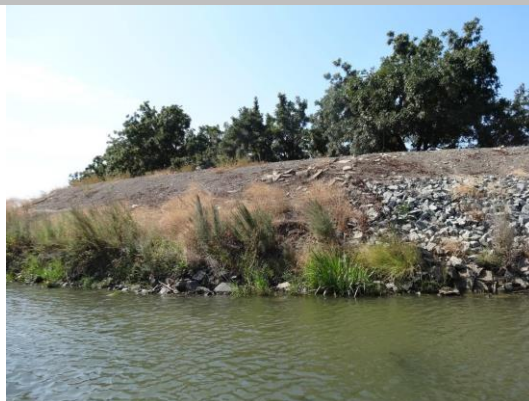
Photo 3 of 3 : SP_2018_RD0524_107_70_20180323_00142.jpg

Front view of the erosion.

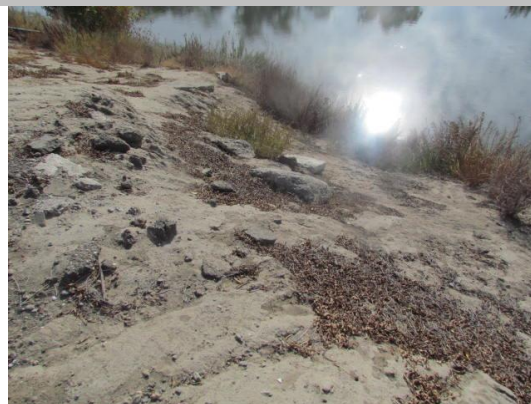
Photo 1 of 1 : SP_2018_RD0524_107_36_20180323_00080.jpg

LM Start	2.44	Rating **	M	Issue No.	36
LM End	2.47	Issue Type +	Ma	Location *	WS
Category	Earthen Levee			GPS Latitude/Longitude	
				Start	End
Item	Erosion / Bank Caving			37.918628 °	37.918438 °
				-121.320817 °	-121.321452 °
DWR ID	DWR_RD0524_01_s_2012_36				
Comment Code					
E1 : Note and monitor erosion site.					
Inspector Comment

Looking east at erosion on waterside slope.

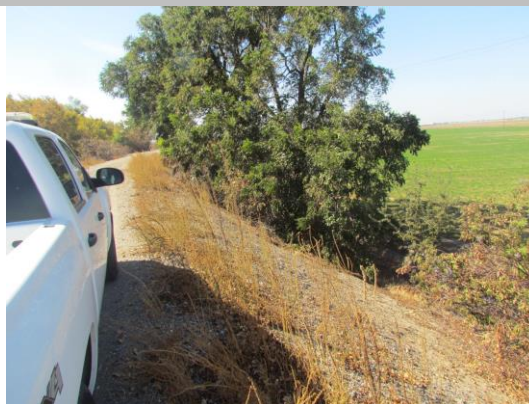
Photo 1 of 1 : SP_2018_RD0524_107_80_20180323_00160.jpg

LM Start	2.45	Rating **	U	Issue No.	80
LM End	2.45	Issue Type +	Ma	Location *	LS
Category	Earthen Levee			GPS Latitude/Longitude	
				Start	End
Item	Trim / Thin Trees			37.918480 °	37.918480 °
				-121.321114 °	-121.321114 °
DWR ID	DWR_RD0524_01_s_2012_80				
Comment Code					
T1 : Trim trees to at least five feet above ground level.					
Inspector Comment					
Untrimmed tree on landside slope.

Looking south at untrimmed tree on landward slope.

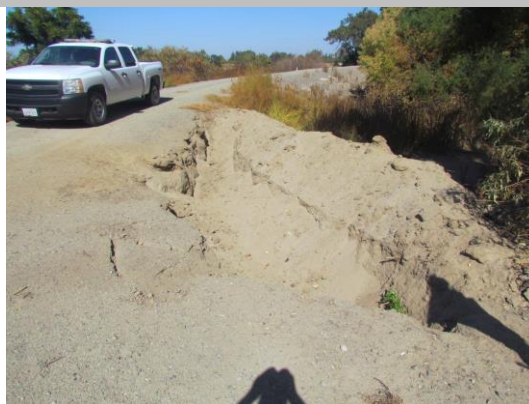
Photo 2 of 3 : SP_2018_RD0524_107_218_20180323_00301.jpg

LM Start	2.57	Rating **	U	Issue No.	218
LM End	2.57	Issue Type +	Ma	Location *	WS
Category	Earthen Levee			GPS Latitude/Longitude	
				Start	End
Item	Erosion / Bank Caving			37.917492 °	37.917492 °
				-121.322795 °	-121.322795 °
DWR ID	DWR_RD0524_01_f_2016_218				
Comment Code					
E2 : Schedule repair of erosion site prior to the next inspection.					
Inspector Comment					
Large trench on waterside shoulder and slope. Trench is 45 x 15 x 5.

Looking northwest at trench on waterward shoulder.

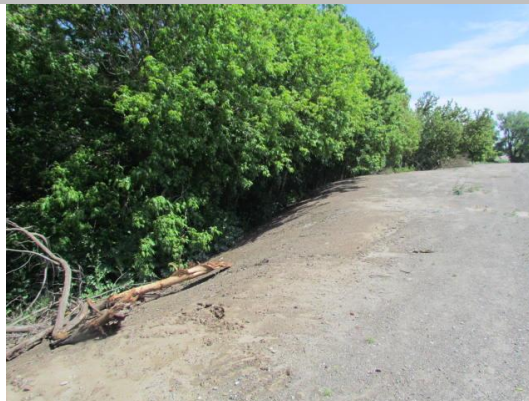
Photo 1 of 1 : SP_2018_RD0524_107_185_20180323_00259.jpg

LM Start	2.60	Rating **	U	Issue No.	185
LM End	2.64	Issue Type +	Ma	Location *	WS
Category	Earthen Levee			GPS Latitude/Longitude	
				Start	End
Item	Trim / Thin Trees			37.917152 °	37.916807 °
				-121.322582 °	-121.322069 °
DWR ID	DWR_RD0524_01_s_2014_185				
Comment Code					
T2 : Thin trees to allow visibility of the ground and room to flood fight.					
Inspector Comment

Looking northwest at untrimmed trees on landward slope and toe.

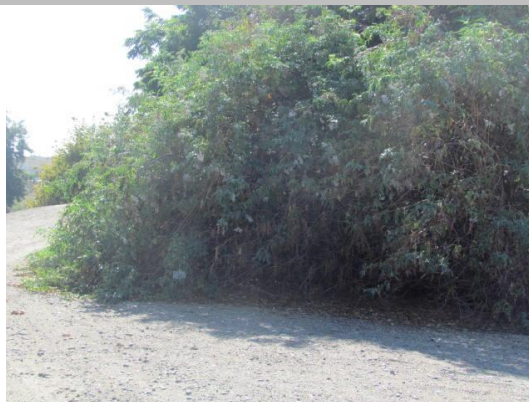
Photo 1 of 1 : SP_2018_RD0524_107_43_20180323_00093.jpg

LM Start	2.64	Rating **	U	Issue No.	43
LM End	2.64	Issue Type +	Ma	Location *	LS
Category	Earthen Levee			GPS Latitude/Longitude	
				Start	End
Item	Vegetation			37.916780 °	37.916780 °
				-121.322095 °	-121.322095 °
DWR ID	DWR_RD0524_01_s_2012_43				
Comment Code					
V4 : Elderberries are blocking visibility and flood fight capability.					
Inspector Comment					
Dense elderberry on landside shoulder, slope, and toe.

Looking southeast at dense veg on landward slope and toe fall 2015.

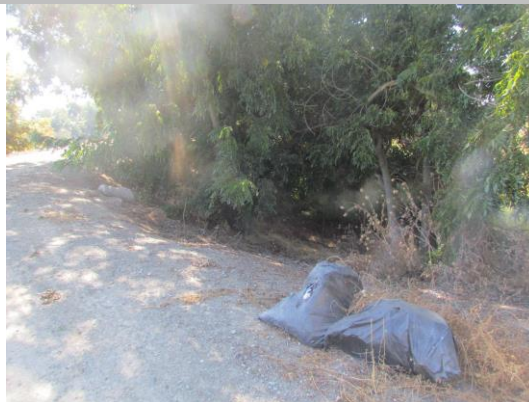
Photo 1 of 1 : SP_2018_RD0524_107_918_20180323_00384.jpg

LM Start	2.65	Rating **	U	Issue No.	918
LM End	2.66	Issue Type +	Ma	Location *	LS
Category	Earthen Levee			GPS Latitude/Longitude	
				Start	End
Item	Trim / Thin Trees			37.916718 °	37.916502 °
				-121.322020 °	-121.321980 °
DWR ID	DWR_RD0524_01_s_2012_918				
Comment Code					
T1 : Trim trees to at least five feet above ground level.					
Inspector Comment					
Untrimmed trees on landside slope and toe.

Looking south at untrimmed trees on landward slope.

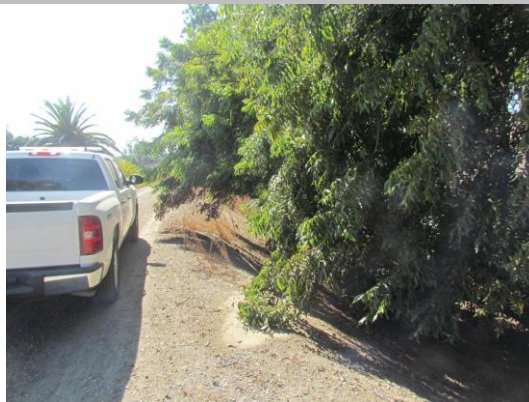
Photo 1 of 2 : SP_2018_RD0524_107_264_20180323_00369.jpg

LM Start	2.70	Rating **	M	Issue No.	264
LM End	2.76	Issue Type +	Ma	Location *	LS
Category	Earthen Levee			GPS Latitude/Longitude	
				Start	End
Item	Trim / Thin Trees			37.915945 °	37.915276 °
				-121.322290 °	-121.322808 °
DWR ID	DWR_RD0524_01_s_2012_264				
Comment Code					
T2 : Thin trees to allow visibility of the ground and room to flood fight.					
Inspector Comment					
Untrimmed trees along landside slope and toe. Additionally, trim over hanging trees at least 12 feet above ground level.

Looking south at untrimmed trees on landward slope.

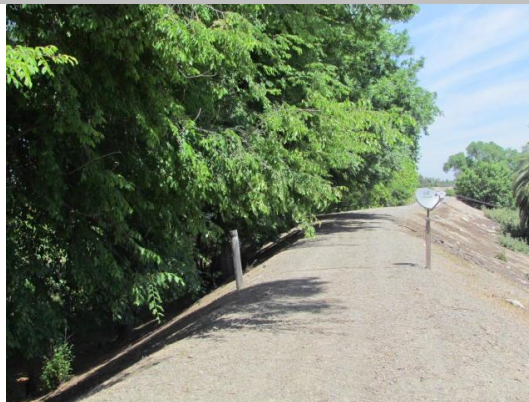
Photo 2 of 2 : SP_2018_RD0524_107_264_20180323_00370.jpg

Looking north at dense trees overhanging levee crown.

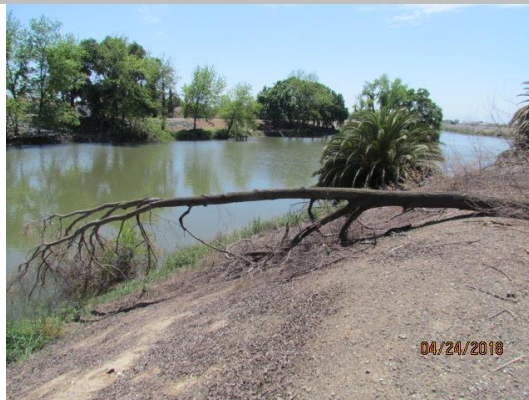
Photo 1 of 3 : SP_2018_RD0524_107_152_20180427_00499.jpg

LM Start	2.75	Rating **	U	Issue No.	152
LM End	2.75	Issue Type +	Ma	Location *	CR
Category	Earthen Levee			GPS Latitude/Longitude	
				Start	End
Item	Encroachments			37.915427 °	37.915427 °
				-121.322691 °	-121.322691 °
DWR ID	DWR_RD0524_01_s_2018_152				
Comment Code					
TR : Tree or limb					
Inspector Comment					
Large tree branch across levee crown. Block access to levee.

Looking south at fallen tree on waterward slope. (Spring 2018)

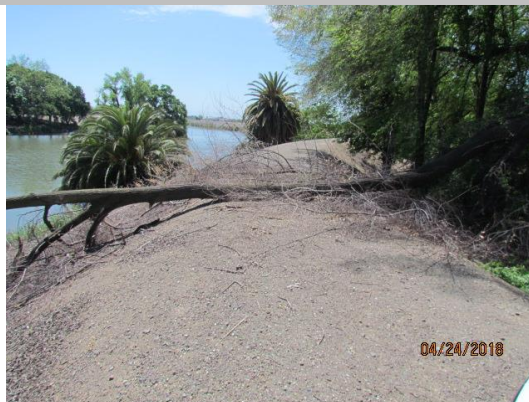
Photo 2 of 3 : SP_2018_RD0524_107_152_20180427_00498.jpg

Looking south at fallen tree across levee crown. (Spring 2018)

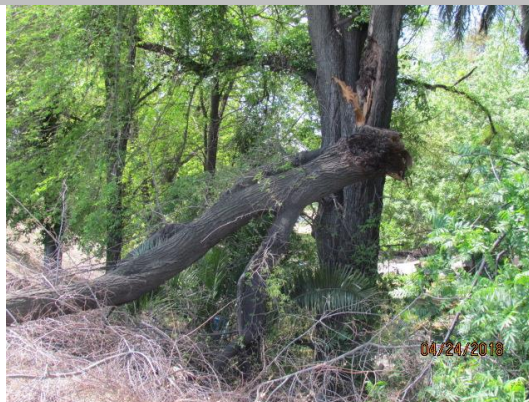
Photo 3 of 3 : SP_2018_RD0524_107_152_20180427_00500.jpg

Looking southwest at broken tree branch on landward slope. (Spring 2018)

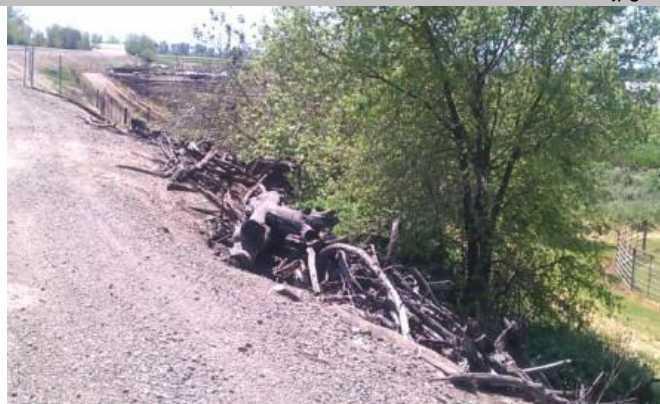
Photo 1 of 1 : SP_2018_RD0524_107_50_20180323_00112.jpg

LM Start	2.90	Rating **	U	Issue No.	50
LM End	2.92	Issue Type +	Ma	Location *	LS
Category	Earthen Levee			GPS Latitude/Longitude	
				Start	End
Item	Encroachments			37.913767 °	37.913486 °
				-121.324427 °	-121.324428 °
DWR ID	DWR_RD0524_01_s_2012_50				
Comment Code					
PR : Prunings					
Inspector Comment

Looking southwest at prunings on landside slope.

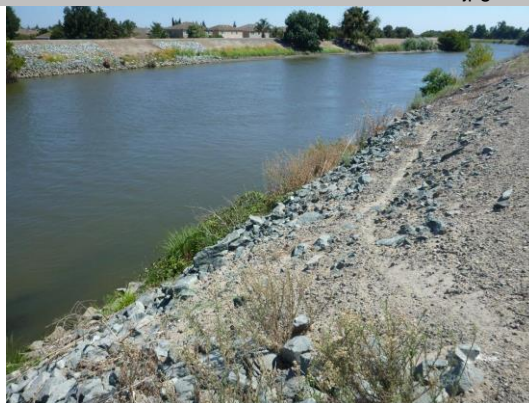
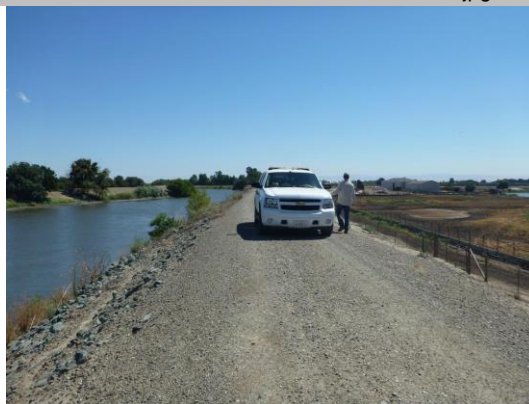
LM Start	2.96	Rating **	A/W	Issue No.	227
LM End		Issue Type +	Ma	Location *	
Category	Supplemental			GPS Latitude/Longitude	
				Start	End
Item	2017 Storm Damage			37.912900 °	°
				-121.324400 °	°
DWR ID	DWR RD0524 01 f 2017 227

Description: Slope protection repairs are needed along the waterside slope due to erosion. Based upon levee inspections, it was determined the waterside levee slopes were eroding, deteriorating and degrading in concave pocket sections at various locations along this levee reach. The eroded levee sections need to be restored back to design standards to prevent further deterioration of the damaged levee sections.

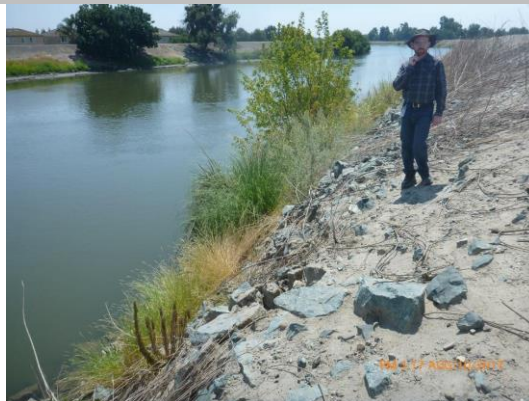
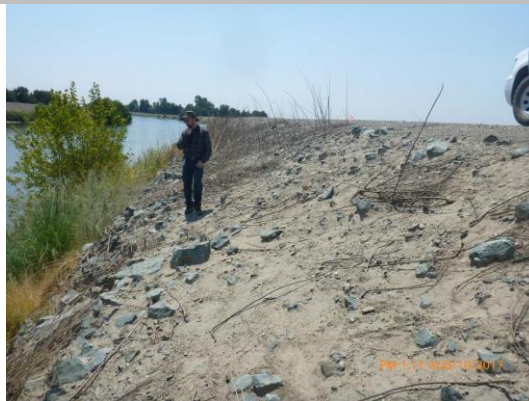
LM Start	2.99	Rating **	A/W	Issue No.	228
LM End	3.01	Issue Type +	Ma	Location *	
Category	Supplemental			GPS Latitude/Longitude	
				Start	End
Item	2017 Storm Damage			37.912500 °	37.912300 °
				-121.324700 °	-121.324700 °
DWR ID	DWR_RD0524_01_f_2017_228				
Comment Code					
Inspector Comment					
Levee Evaluation Comments					
Description:Slope protection repairs are needed along the waterside slope due to erosion and riprap displacement from high water. Based upon levee inspections, it was determined the waterside levee slope is eroding, deteriorating, and degrading. The eroded levee sections need to be restored back to design standards to prevent further deterioration and damage.					
Site ID No:529					
Site Designation:LMA-435					
Repair Type: Erosion					
Rating:Area of Concern					
Field Date:8/10/2017					
Notes:

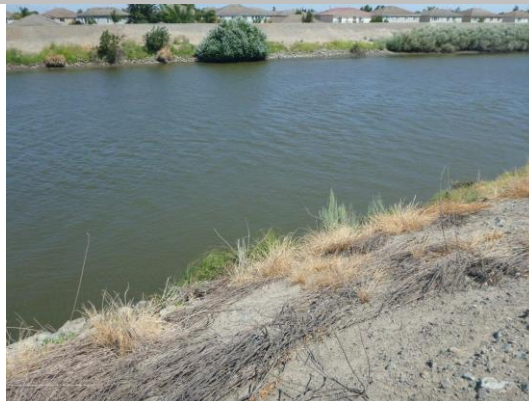
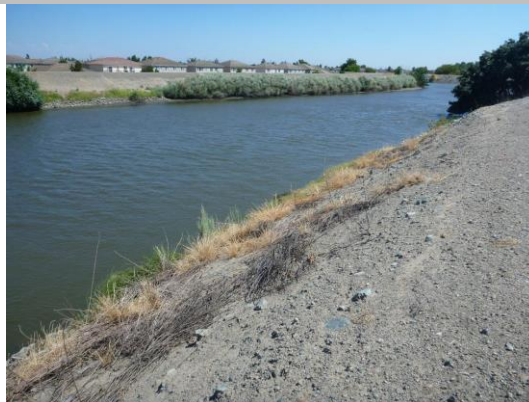
LM Start	3.23	Rating **	A/W	Issue No.	229
LM End		Issue Type +	Ma	Location *	
Category	Supplemental		GPS Latitude/Longitude		
			Start	End	
Item	2017 Storm Damage		37.909200 °		°
			-121.325300 °		°

Description: Slope protection repairs are needed along the waterside slope due to erosion. Based upon levee inspections, it was determined the waterside levee slopes were eroding, deteriorating and degrading in concave pocket sections at various locations along this levee reach. The eroded levee sections need to be restored back to design standards to prevent further deterioration of the damaged levee sections.

Notes: Lower priority because damage is only on the lower 1/5 of slope. The slopes US and DS are rocky. Levee is narrow here.

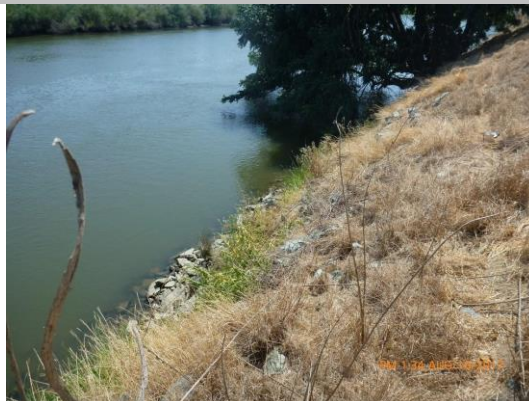
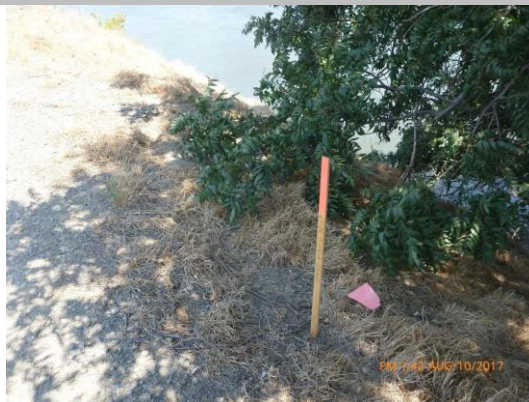
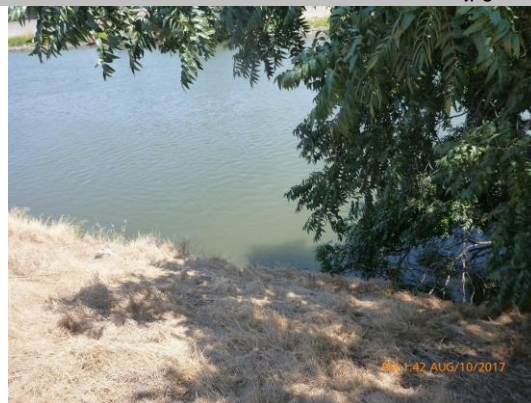
LM Start	3.26	Rating **	A/W	Issue No.	230
LM End	3.26	Issue Type +	Ma	Location *	
Category	Supplemental			GPS Latitude/Longitude	
				Start	End
Item	2017 Storm Damage			37.908800 °	37.908700 °
				-121.325400 °	-121.325300 °
DWR ID	DWR_RD0524_01_f_2017_230				
Comment Code					
Inspector Comment					
Levee Evaluation Comments					
Description:Slope protection repairs are needed along the waterside slope due to erosion and riprap displacement from high water. Based upon levee inspections, it was determined the waterside levee slope is eroding, deteriorating, and degrading. The eroded levee sections need to be restored back to design standards to prevent further deterioration and damage.					
Site ID No:528					
Site Designation:LMA-434					
Repair Type: Erosion					
Rating:Area of Concern					
Field Date:8/10/2017					
Notes: combined with LMA-433

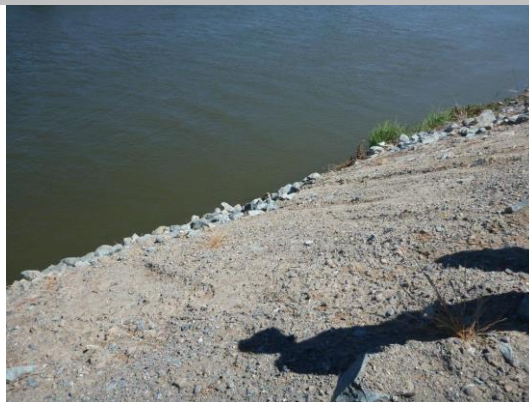
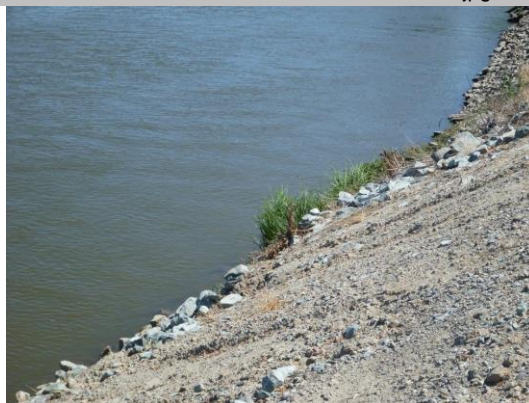
Comment Code					
Inspector Comment					
Levee Evaluation Comments					
Description:Slope protection repairs are needed along the waterside slope due to erosion. Based upon levee inspections, it was determined the waterside levee slopes were eroding, deteriorating and degrading in concave pocket sections at various locations along this levee reach. The eroded levee sections need to be restored back to design standards to prevent further deterioration of the damaged levee sections.					
Site ID No:467					
Site Designation:LMA-294					
Repair Type: Erosion					
Rating:Area of Concern					
Field Date:7/26/2017					
Notes: It looks like new rip rap was played on the lower 1/4 of the slope. There is a 2-3 ft scarp above the rip rap.

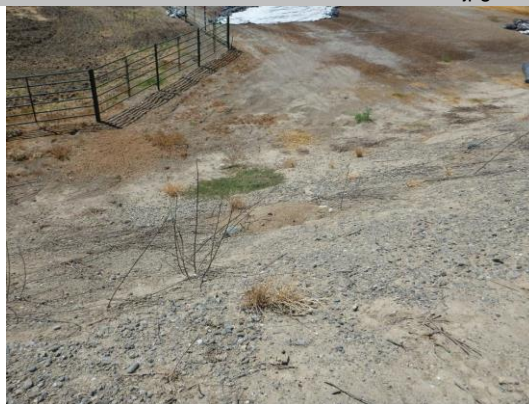
Photo 3 of 3 : LEVAL_SP_2018_467_2225.jpg

Comment Code						
Inspector Comment						
Levee Evaluation Comments						
Description:Slope protection repairs are needed along the waterside slope due to erosion. Based upon levee inspections, it was determined the waterside levee slopes were eroding, deteriorating and degrading in concave pocket sections at various locations along this levee reach. The eroded levee sections need to be restored back to design standards to prevent further deterioration of the damaged levee sections.						
Site ID No:467						
Site Designation:LMA-294						
Repair Type: Erosion						
Rating:Area of Concern						
Field Date:7/26/2017						
Notes: It looks like new rip rap was played on the lower 1/4 of the slope. There is a 2-3 ft scarp above the rip rap.

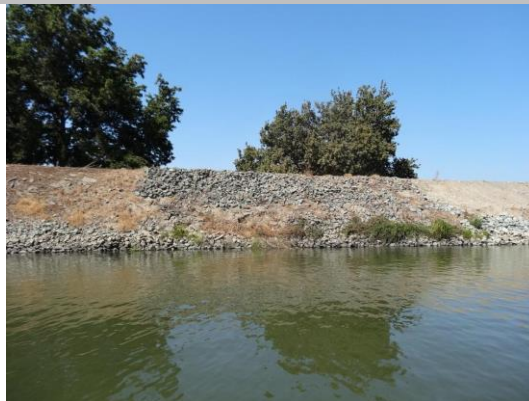
Photo 1 of 4 : SP_2018_RD0524_107_79_20180323_00156.jpg

LM Start	3.30	Rating **	U	Issue No.	79
LM End	3.32	Issue Type +	Ma	Location *	WS
Category	Supplemental			GPS Latitude/Longitude	
				Start	End
Item	DWR Erosion Survey			37.908090 °	37.908090 °
				-121.325090 °	-121.325090 °
DWR ID	RD0524U01RM43.86				
Comment Code					
Inspector Comment					
09/13/2017: No significant change observed.					
07/25/2016: No significant change observed.					
06/24/2015: No significant change observed.					
06/19/2014: No significant change observed.					
08/13/2013: The levee toe seems to have been protected by river rocks and vegetation on site. [2017 Site ID:RD0524U01RM43.86]

Front View of the erosion.

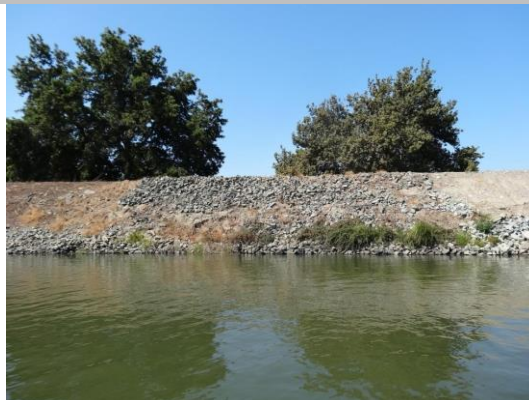
Photo 2 of 4 : SP_2018_RD0524_107_79_20180323_00157.jpg

Front view of the erosion.

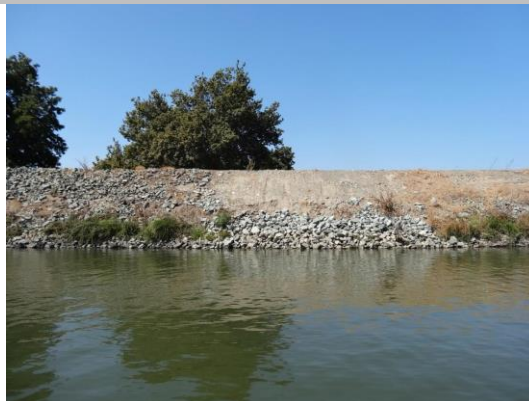
Photo 3 of 4 : SP_2018_RD0524_107_79_20180323_00158.jpg

Close view of the erosion. Note the river rocks and vegetation at the levee toe.

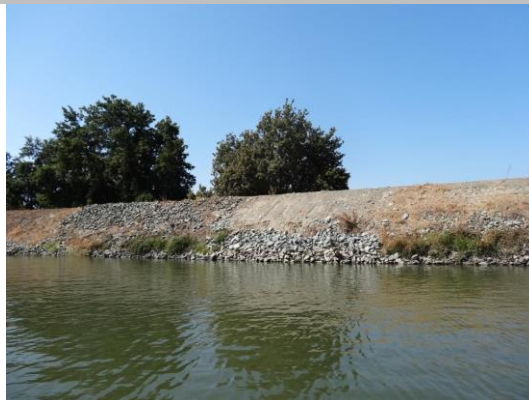
Photo 4 of 4 : SP_2018_RD0524_107_79_20180323_00159.jpg

Front View of the erosion.

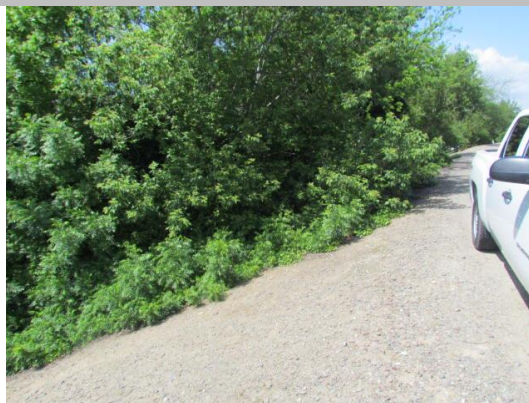
Photo 1 of 2 : SP_2018_RD0524_107_926_20180323_00390.jpg

LM Start	3.30	Rating **	U	Issue No.	926
LM End	3.37	Issue Type +	Ma	Location *	LS
Category	Earthen Levee			GPS Latitude/Longitude	
				Start	End
Item	Trim / Thin Trees			37.908158 °	37.907112 °
				-121.325418 °	-121.325350 °
DWR ID	DWR_RD0524_01_s_2012_926				
Comment Code					
T1 : Trim trees to at least five feet above ground level.					
Inspector Comment

Looking southwest at dense veg on landward slope.

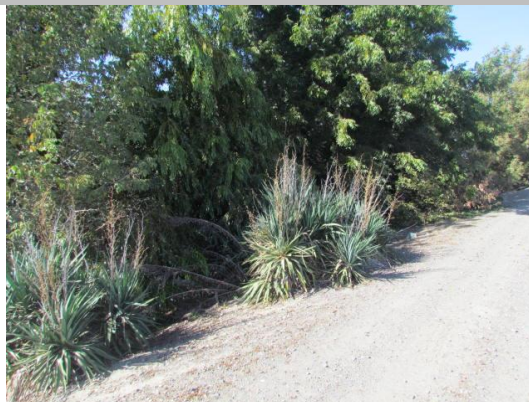
Photo 1 of 1 : SP_2018_RD0524_107_54_20180323_00116.jpg

LM Start	3.45	Rating **	U	Issue No.	54
LM End	3.45	Issue Type +	Ma	Location *	LS
Category	Earthen Levee			GPS Latitude/Longitude	
				Start	End
Item	Trim / Thin Trees			37.906227 °	37.906227 °
				-121.324683 °	-121.324683 °
DWR ID	DWR_RD0524_01_s_2012_54				
Comment Code					
T3 : Trim and thin trees to allow visibility of the ground and room to flood fight.					
Inspector Comment					
Dense untrimmed trees on landside slope.

Looking northwest at dense vegetation on landside slope.

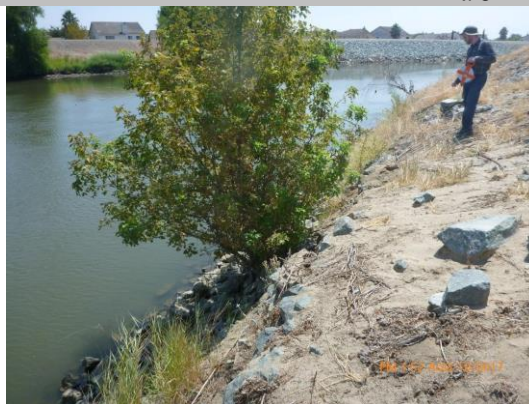
Photo 1 of 3 : LEVAL_SP_2018_526_4201.jpg

LM Start	3.53	Rating **	A/W	Issue No.	233
LM End	3.54	Issue Type +	Ma	Location *	
Category	Supplemental			GPS Latitude/Longitude	
				Start	End
Item	2017 Storm Damage			37.905300 °	37.905200 °
				-121.323800 °	-121.323900 °
DWR ID	DWR_RD0524_01_f _ 2017_233				
Comment Code					
Inspector Comment					
Levee Evaluation Comments					
Description:Slope protection repairs are needed along the waterside slope due to erosion and riprap displacement from high water. Based upon levee inspections, it was determined the waterside levee slope is eroding, deteriorating, and degrading. The eroded levee sections need to be restored back to design standards to prevent further deterioration and damage.					
Site ID No:526					
Site Designation:LMA-432					
Repair Type: Erosion					
Rating:Area of Concern					
Field Date:8/10/2017					
Notes:

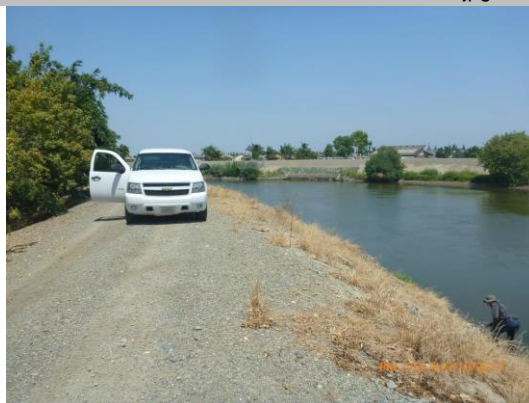
Photo 3 of 3 : LEVAL_SP_2018_525_4208.jpg

LM Start	3.56	Rating **	A/W	Issue No.	234 (cont)							
LM End	3.57	Issue Type +	Ma	Location *								
Category	Supplemental		GPS Latitude/Longitude									
			Start	End								
Item	2017 Storm Damage		37.904900 °	37.904800 °								
			-121.323900 °	-121.324100 °								
DWR ID	DWR_RD0524_01_f_2017_234											
Comment Code												
Inspector Comment												
Levee Evaluation Comments Description: Slope protection repairs are needed along the waterside slope due to erosion and riprap displacement from high water. Based upon levee inspections, it was determined the waterside levee slope is eroding, deteriorating, and degrading. The eroded levee sections need to be restored back to design standards to prevent further deterioration and damage. Site ID No: 525 Site Designation: LMA-431 Repair Type: Erosion Rating: Area of Concern Field Date: 8/10/2017 Notes:

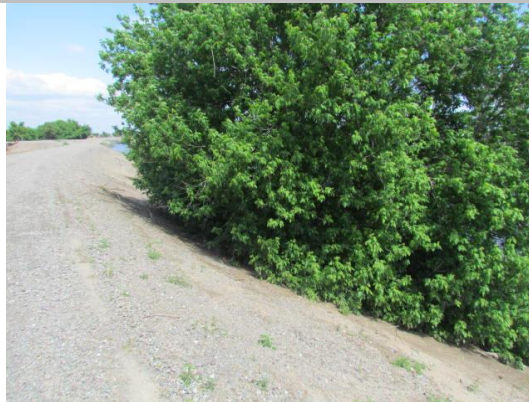
Photo 1 of 1 : SP_2018_RD0524_107_52_20180323_00115.jpg

LM Start	3.75	Rating **	U	Issue No.	52
LM End	3.75	Issue Type +	Ma	Location *	WS
Category	Earthen Levee			GPS Latitude/Longitude	
				Start	End
Item	Trim / Thin Trees			37.902828 °	37.902828 °
				-121.326170 °	-121.326170 °
DWR ID	DWR_RD0524_01_s_2016_52				
Comment Code					
T1 : Trim trees to at least five feet above ground level.					
Inspector Comment

Looking south at untrimmed tree on landward slope and toe.

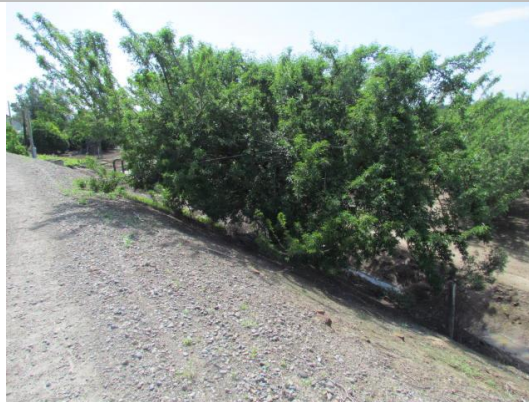
Photo 1 of 1 : SP_2018_RD0524_107_927_20180323_00392.jpg

LM Start	3.77	Rating **	U	Issue No.	927
LM End	3.77	Issue Type +	Ma	Location *	LS
Category	Earthen Levee			GPS Latitude/Longitude	
				Start	End
Item	Trim / Thin Trees			37.902645 °	37.902645 °
				-121.326340 °	-121.326340 °
DWR ID	DWR_RD0524_01_s_2012_927				
Comment Code					
T1 : Trim trees to at least five feet above ground level.					
Inspector Comment					
Untrimmed almond tree on landside slope.

Looking southwest at untrimmed tree at landward toe.

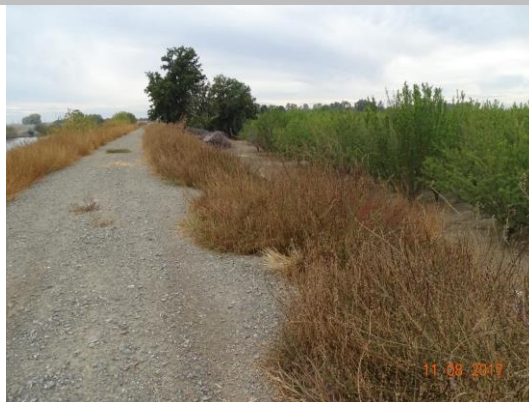
Photo 1 of 1 : SP_2018_RD0524_107_253_20180323_00358.jpg

LM Start	3.97	Rating **	U	Issue No.	253
LM End	4.02	Issue Type +	Ma	Location *	LS
Category	Earthen Levee			GPS Latitude/Longitude	
				Start	End
Item	Vegetation			37.899748 °	37.899116 °
				-121.326596 °	-121.326905 °
DWR ID	DWR_RD0524_01_f_2017_253				
Comment Code					
V2 : Remove the wild growth other than native grasses from the levee slopes.					
Inspector Comment

Looking southwest at the landside slope.

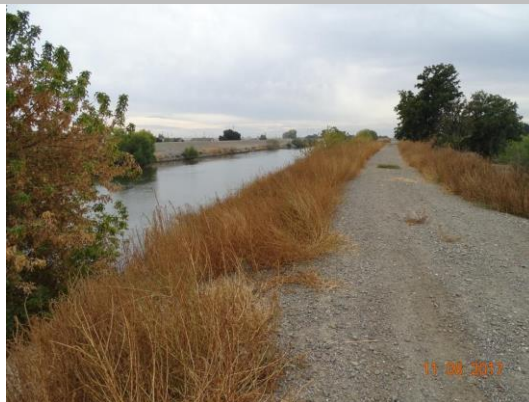
Photo 1 of 1 : SP_2018_RD0524_107_254_20180323_00359.jpg

LM Start	3.97	Rating **	U	Issue No.	254
LM End	4.03	Issue Type +	Ma	Location *	WS
Category	Earthen Levee			GPS Latitude/Longitude	
				Start	End
Item	Vegetation			37.899718 °	37.898945 °
				-121.326605 °	-121.327003 °
DWR ID	DWR_RD0524_01_f_2017_254				
Comment Code					
V2 : Remove the wild growth other than native grasses from the levee slopes.					
Inspector Comment

Looking southwest at the waterside slope.

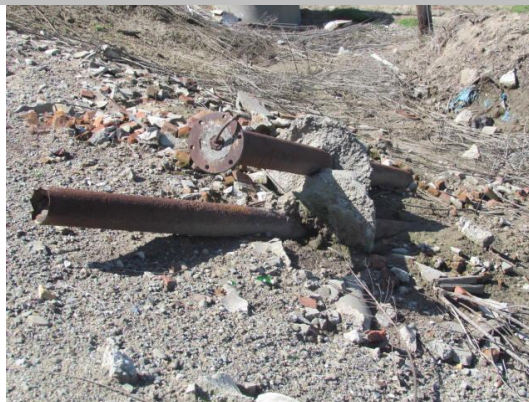
Photo 1 of 1 : SP_2018_RD0524_107_213_20180323_00295.jpg

LM Start	4.16	Rating **	M	Issue No.	213
LM End	4.16	Issue Type +	Ma	Location *	LS
Category	Earthen Levee			GPS Latitude/Longitude	
				Start	End
Item	Encroachments			37.897235 °	37.897235 °
				-121.327865 °	-121.327865 °
DWR ID	DWR_RD0524_01_s_2016_213				
Comment Code					
GA : Garbage					
Inspector Comment					
Old fence post and concrete and brick rubble on landside slope.

Looking west at old fence post and concrete rubble on landward slope.

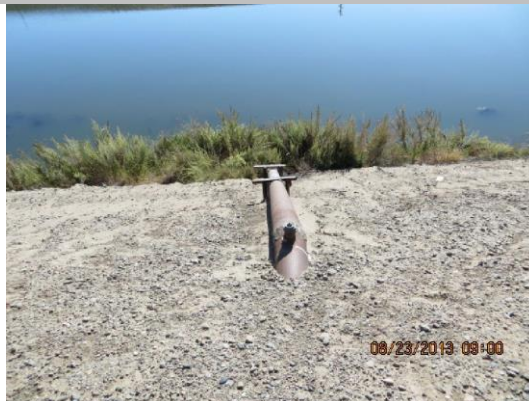
Photo 1 of 3 : UCIP_SP_2018_18320_30594.jpg

Pipe and siphon breaker on WS slope.

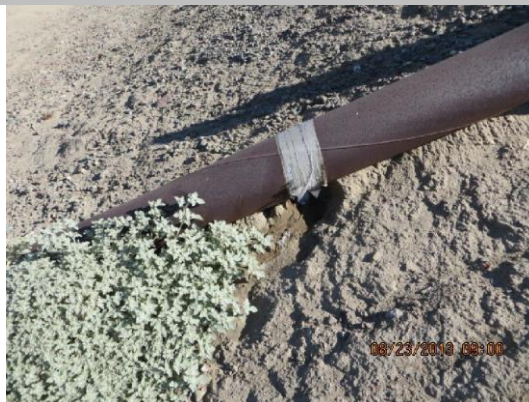
Photo 2 of 3 : UCIP_SP_2018_18320_30593.jpg

Small leak in pipe on LS slope.

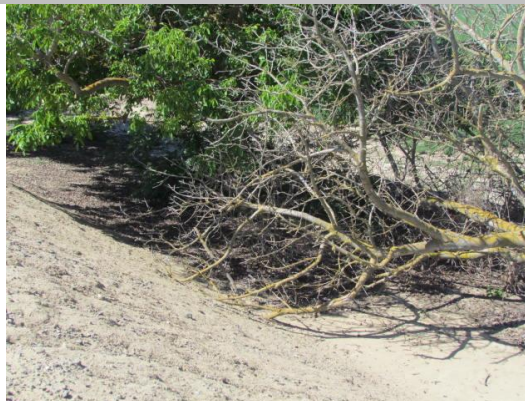
Photo 1 of 1 : SP_2018_RD0524_107_111_20180323_00194.jpg

LM Start	4.38	Rating **	M	Issue No.	111
LM End	4.38	Issue Type +	Ma	Location *	LS
Category	Earthen Levee			GPS Latitude/Longitude	
				Start	End
Item	Encroachments			37.894258 °	37.894258 °
				-121.329247 °	-121.329247 °
DWR ID	DWR_RD0524_01_s_2012_111				
Comment Code					
TR : Tree or limb					
Inspector Comment					
Dead tree at landside toe should be removed from levee toe.

Looking west at dead tree at landside toe.

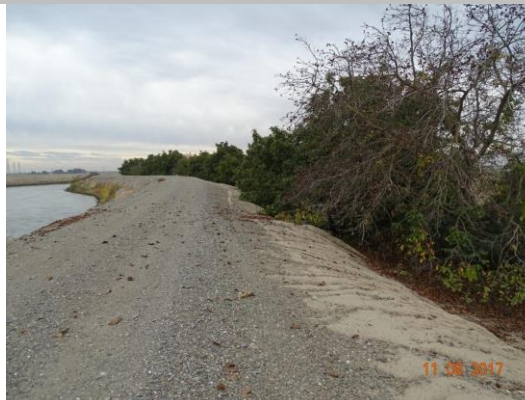
Photo 1 of 3 : SP_2018_RD0524_107_112_20180323_00195.jpg

LM Start	4.40	Rating **	U	Issue No.	112
LM End	4.52	Issue Type +	Ma	Location *	LS
Category	Earthen Levee			GPS Latitude/Longitude	
				Start	End
Item	Trim / Thin Trees			37.893933 °	37.892347 °
				-121.329181 °	-121.328192 °
DWR ID	DWR_RD0524_01_s_2012_112				
Comment Code					
T1 : Trim trees to at least five feet above ground level.					
Inspector Comment					
Untrimmed trees along landside slope and toe.

Looking southeast at the landside slope.

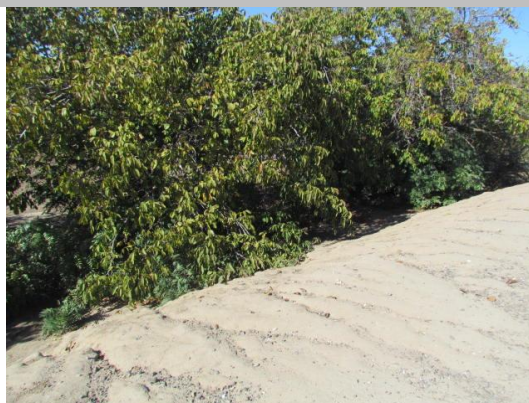
Photo 3 of 3 : SP_2018_RD0524_107_112_20180323_00197.jpg

Looking northeast at untrimmed tree on landward slope and toe fall 2015.
